# HYDROGEOLOGIC CHARACTERIZATION OF FRACTURED ABO AND MADERA FORMATION AQUIFERS, HYDROCARBON CONTAMINATION AND TRANSPORT ALONG THE ZUZAX FAULT, TIJERAS CANYON, NEW MEXICO

**Abstract**—Three separate water producing zones and two localized perched zones were identified within approximately 240 ft of ground surface in the Abo Formation and uppermost Madera Formation during an investigation into gasoline contamination of ground water conducted by the authors for the New Mexico Environment Department (NMED) at the Indian Hills site in the vicinity of Zuzax and Tijeras, New Mexico. Ground-water flow beneath the site occurs in fractured sandstone and limestone beds that are separated by leaky mudstone and shale aquitards. Two separate hydrocarbon plumes located along the Zuzax fault have migrated into both unconfined and leaky-confined aquifers and have contaminated several domestic and commercial wells in the area. A 0.75-mi-long benzene, toluene, ethylbenzene, xylenes (BTEX) and methyl-tert-butyl ether (MTBE) plume and a 500-ft BTEX/EDC (dichloroethane) plume originate from separate locations. Under the influence of down-gradient pumping stresses, contamination of the aquifer located

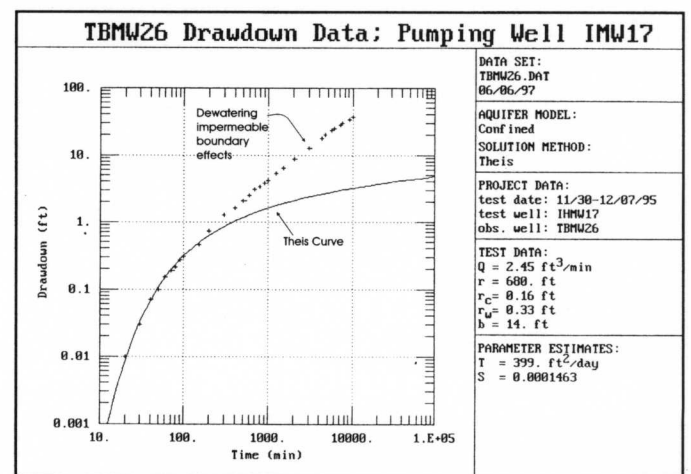
FIGURE 7. Data plot from observation well TBMW26 showing early-time Theis curve-match solution.

Analysis of drawdown data is complicated by recharge derived by leakage from Aquifer A and by impermeable boundary effects caused by the Juniper Ridge and Zuzax faults. Transmissivity (T) of 400 ft<sup>2</sup>/day and storage coefficient (S) of  $1.5 \times 10^{-4}$  that are likely representative of the fracture permeability of the aquifer were calculated from the early-time data from observation well TBMW26 (Fig. 7). Using an average aquifer thickness of 15 ft for Aquifer B, the hydraulic conductivity (K) of the fractured sandstone aquifer is approximately 27 ft/day. The impermeable boundary effects illustrated in Figure 7 are typical of the response of Aquifer B observation wells during the pumping test and indicate dewatering of the aquifer during the test. The 1:1 slope of
